49 Woodside Street, Stamford, CT 06902

November 25, 2012

RE: PCB Cleanup and Disposal Notification
Joseph A. DePaolo Middle School
385 Pleasant Street, Southington, CT

PCB cleanup and disposal notification under § 761.61(a) and § 761.79(n)
Joseph A. DePaolo Middle School, Southington, CT

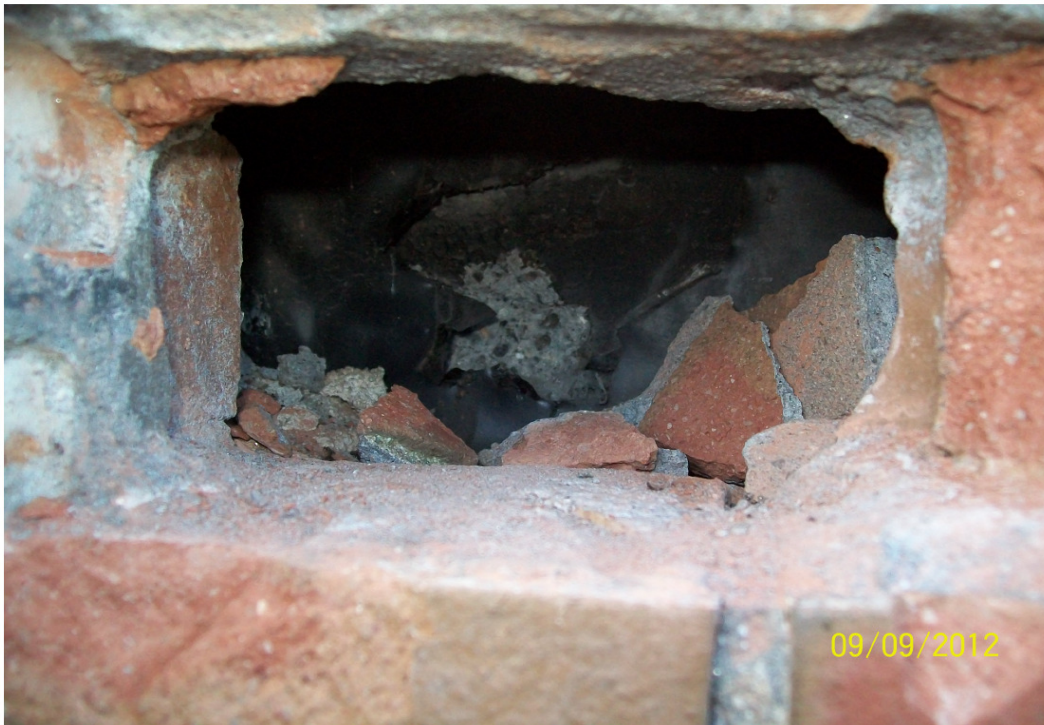
PCB vapor barrier/mastic was applied directly to the building structure on the cinderblock walls between the interior and exterior of the building. The original scope of work for the project was to remove limited locations of the exterior walls to allow new additions to be connected to the original structure. It was never the intention of the Town of Southington to remove the entire exterior wall system and the cost and time delays associated with performing this removal would compromise the entire project. Since the PCB containing material is completely enclosed and inaccessible we are recommending leaving the material in place as an interim solution. The solid block wall on the interior of the building and the solid brick wall on the exterior of the building provide a barricade that eliminates potential exposure pathways or the potential for PCB transfer via direct contact and/or leaching to other building materials. A long-term maintenance and monitoring plan will be required for the site in order to ensure that the material remains in stable

Moisture Barrier Between Exterior Brick Wall & Interior Cinderblock Wall

- PCB-16 Remove existing exterior wall moisture barrier, cinderblock and brick and dispose of PCB Bulk Product Waste >50 PPM.
